**Gypsum in Minoan Architecture: Exploitation,
Utilisation and Weathering of a Prestige Stone**

Vol.I: Text

STEPHANIA CHLOUVERAKI

Institute of Archaeology

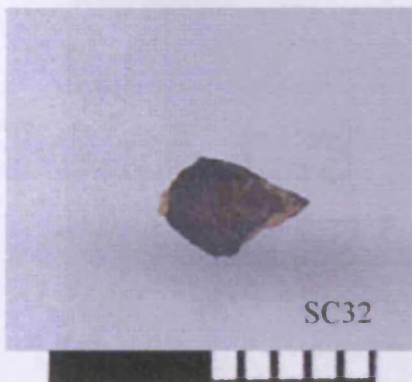
SC32: Pseudomorph after selenite, of which we can see some of the former crystal's cleavage planes. The present texture of the sample is ameboid with elongated crystals. The elongation of the ameboid crystals follows the former crystal cleavage planes. Microcrystalline carbonates also present in the sample.

Knossos, Royal Magazines,
Floor Slab 1057.

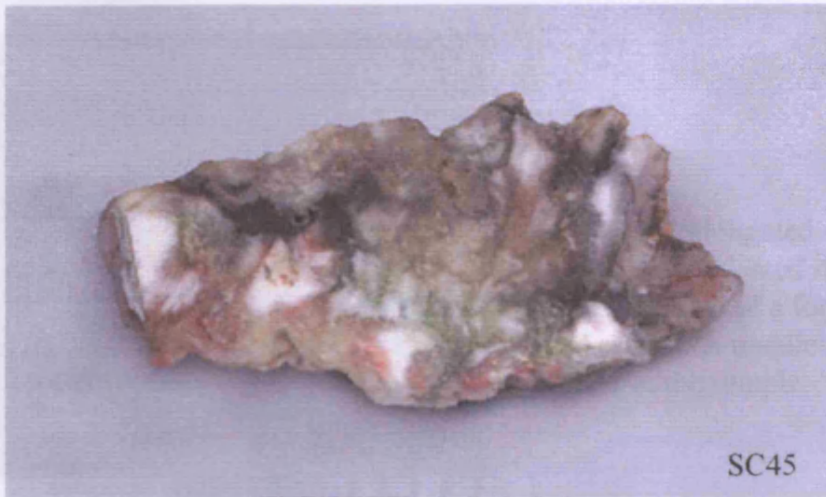
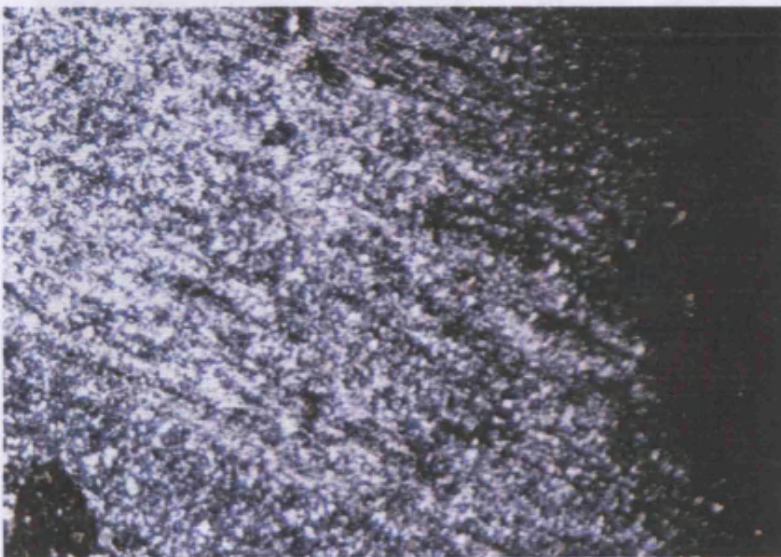
SC45

Knosos, loose fragment, with selenitic pseudomorphs

SC45: crossed polars 2,5x.

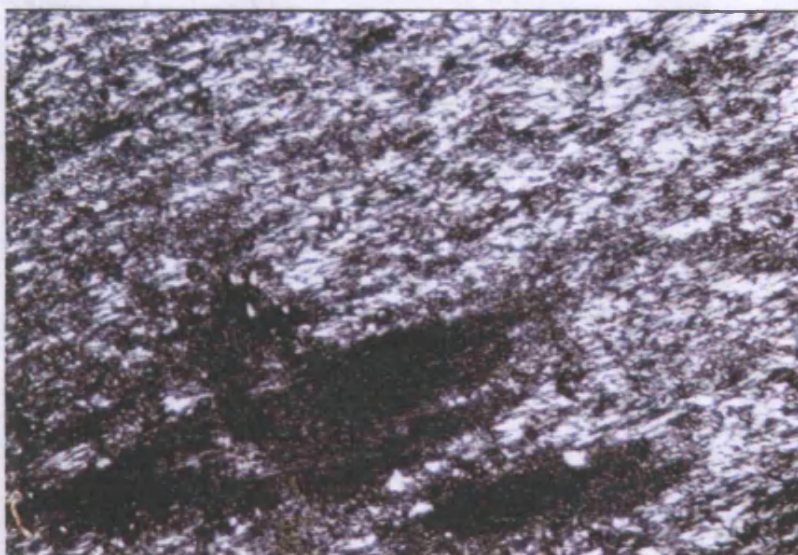
SC19: natural light 2.5x.

Sample 19: elongated ameboid gypsum crystals well oriented resembling former cleavage plains of a former single arrow head crystal. A nodule of chalcedony also present in the sample.

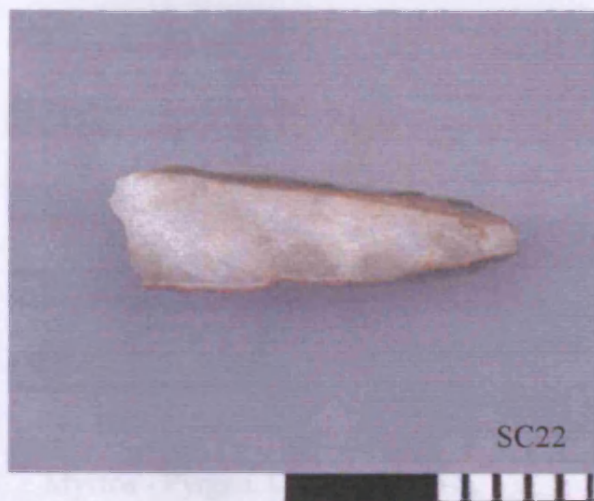
SC22: Mesocrystalline ameboid gypsum, derived from dehydration/rehydration of nodular and lenticular selenite rock. Twin crystal ghosts are visible. Clay particles in between the crystals are probably responsible for the gray coloring of the sample.

Nirou Khani, Loose Slab 262.

SC22: crossed polars 2,5x.

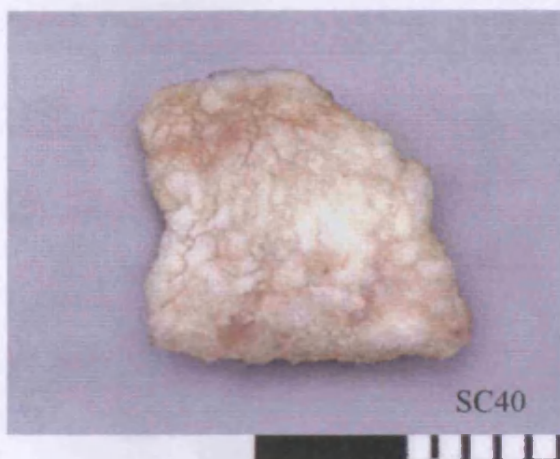
SC40: Microcrystalline elongated ameboid gypsum, which resulting from dehydration/re-hydration of an originally banded selenite. Pseudomorphosed features of the former crystals are visible (step shaped crystal boundaries). Voids distributed at the crystal boundaries represent dissolved clay filling.

Myrtos - Pyrgos, Loose Slab 634.,

SC40: crossed polars, 2.5x.

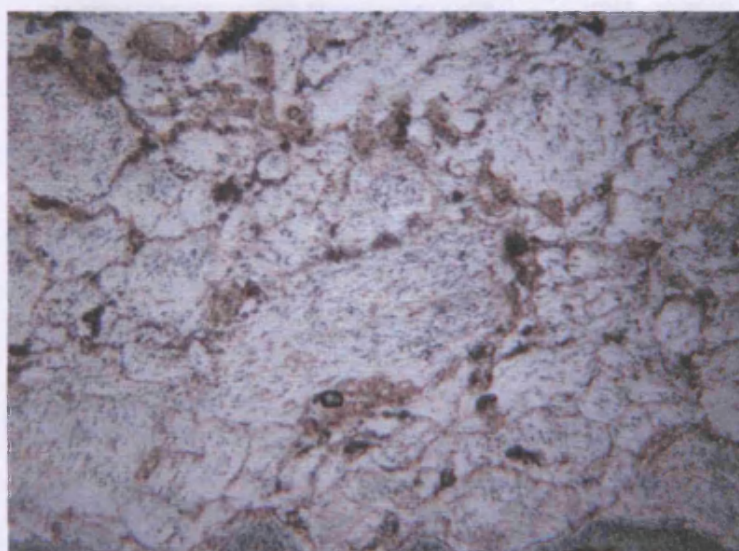
SC40: natural light, 2.5x.

Fig.3.60: step shaped crystal boundaries of pseudomorphosed crystals

Fig.3.60: step shaped crystal boundaries of pseudomorphosed crystals

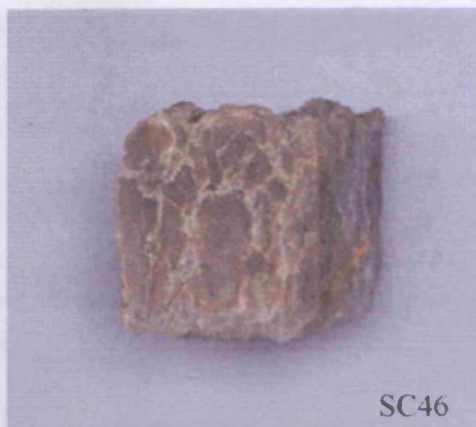
SC46: Ameboid microcrystalline gypsum, coming from the dehydration vertical selenite probably banded that is the typical variety of Pyrgos

Myrtos - Pyrgos, Loose Slab

SC46: crossed polars 2,5x.

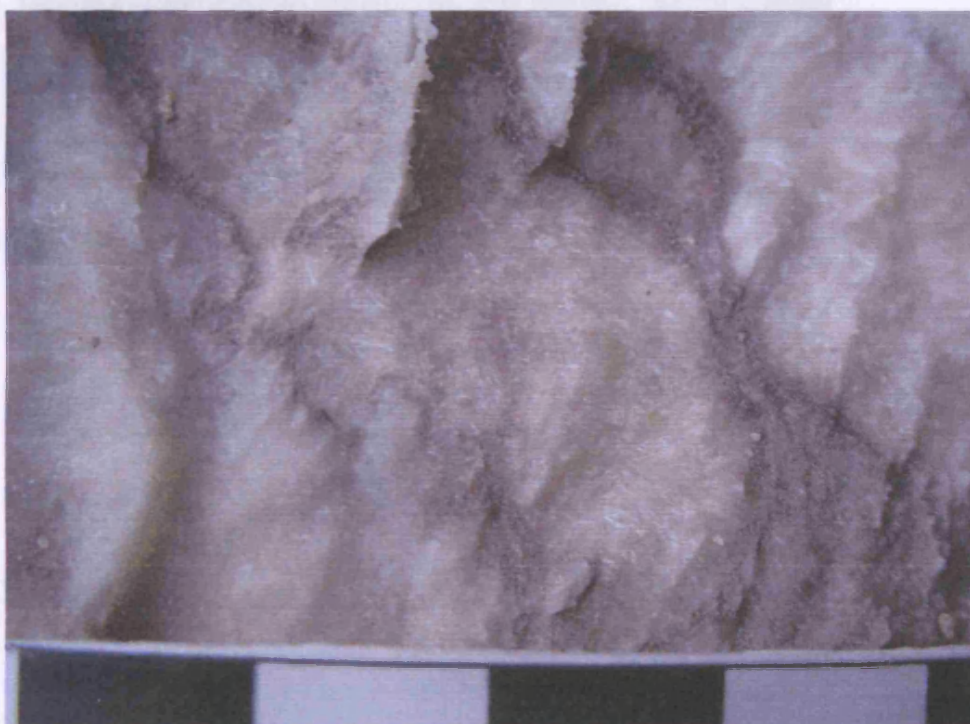
Fig.3.63: nodular and lenticular gypsum affected by fire: pseudomorphs of selenitic crystals are visible on the white higher relief areas areas of the sample while unaffected transparent crystals are visible in the lower relief surfaces (in the middle) that have been exposed after dissolution of the upper affected layer, doorjamb base at the entrance of the North Lustral Basin at Knossos

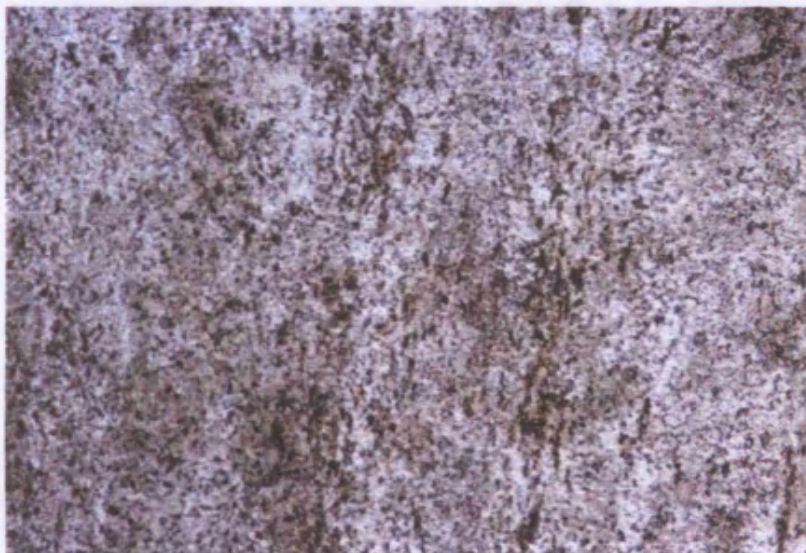
SC34: Laminated ameboid gypsum derived from dehydration – hydration of 'ballatino' or laminated part of nodular and lenticular gypsum. We can see some former needles nearly 2mm long. The coloring owes to the presence of clays and possibly the oxidation of pyrite (iron sulfide).

SC34: natural light 2,5x.

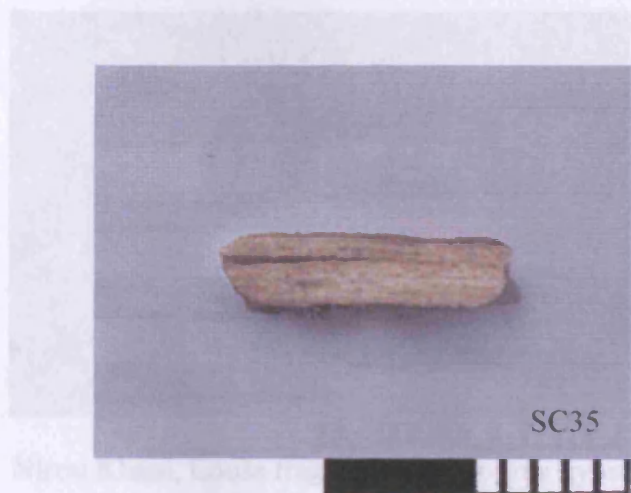
SC35: Elongated ameboid crystals comprised by former 'ballatino' like needles. The sample has undergone dehydration – hydration cycle/s, but this may have happened under natural conditions either at the outcrop or at the building site.

Knossos, grand Staricase, Tread 485.

SC35: crossed polars 2,5x.

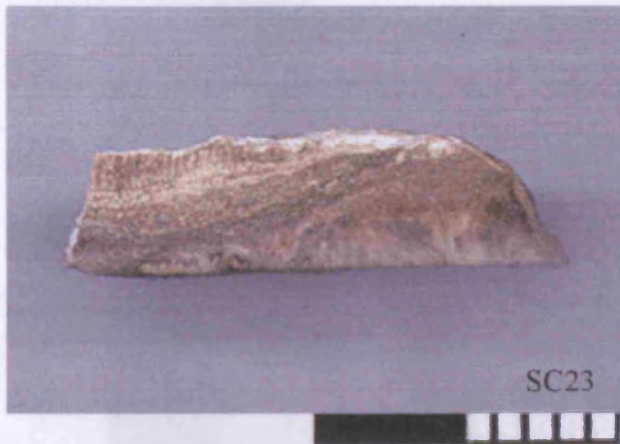
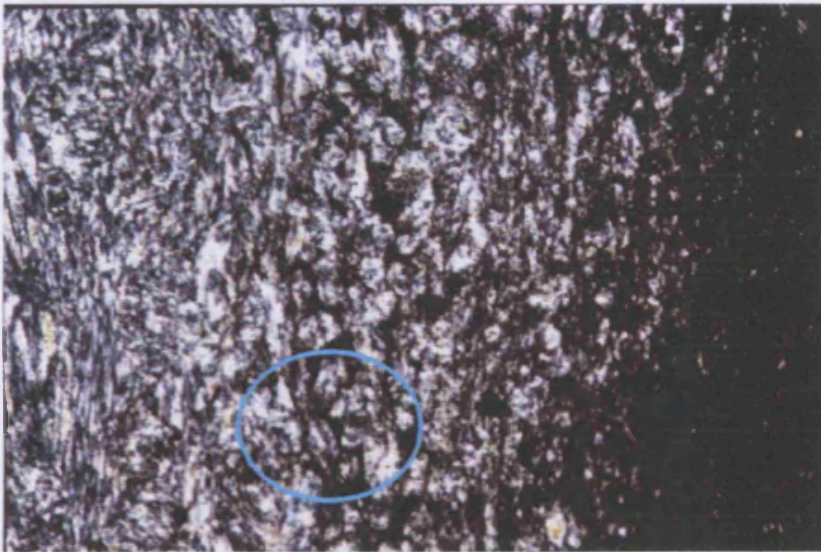
SC23: Graded bedding which varies from mesocrystalline to macrocrystalline. The presence of carbonate matrix makes evident the pseudomorphs of hexagonal crystals (marked in circle on the photos). The hexagonal shapes are now filled with micro-ameboid crystals. The original rock was a nodular and lenticular selenite

Nirou Khani, Loose fragment of dark gray gypsum.

SC23: crossed polars 2,5x.

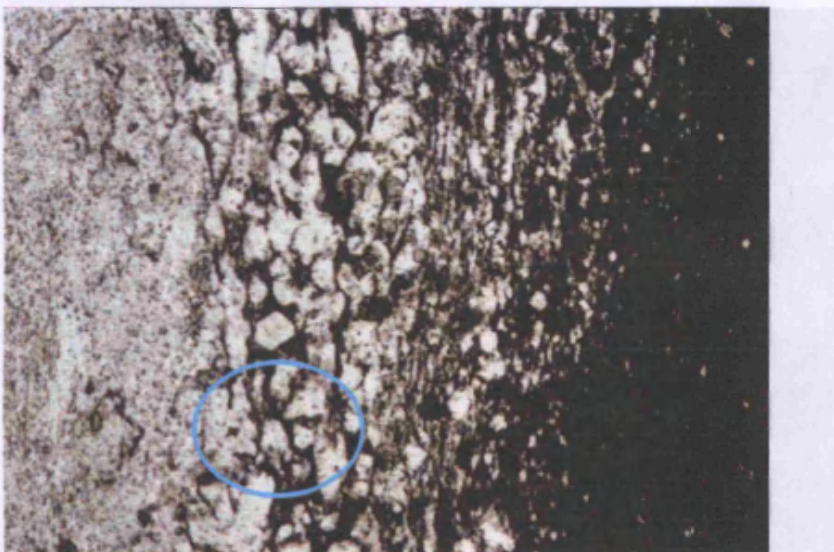
SC23: natural light 2,5x.General view.

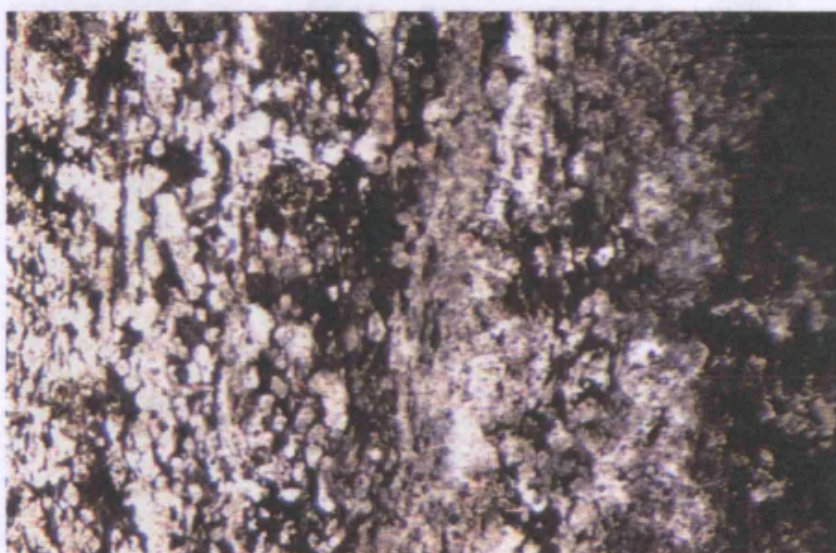
SC52: Pseudomorphosed nodular and lenticular selenite rock

SC52: natural light 2,5x.

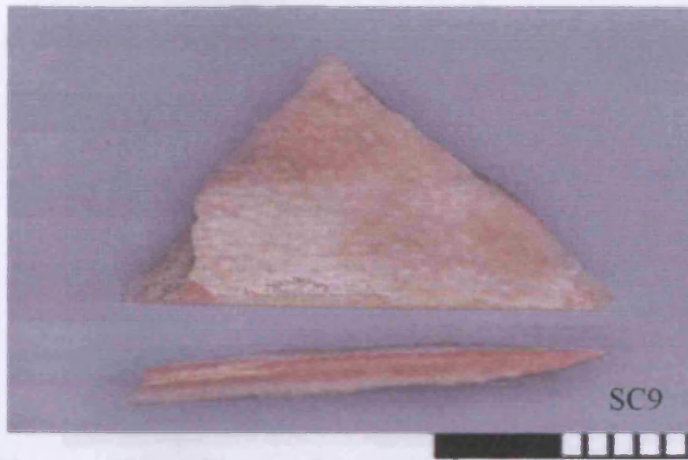
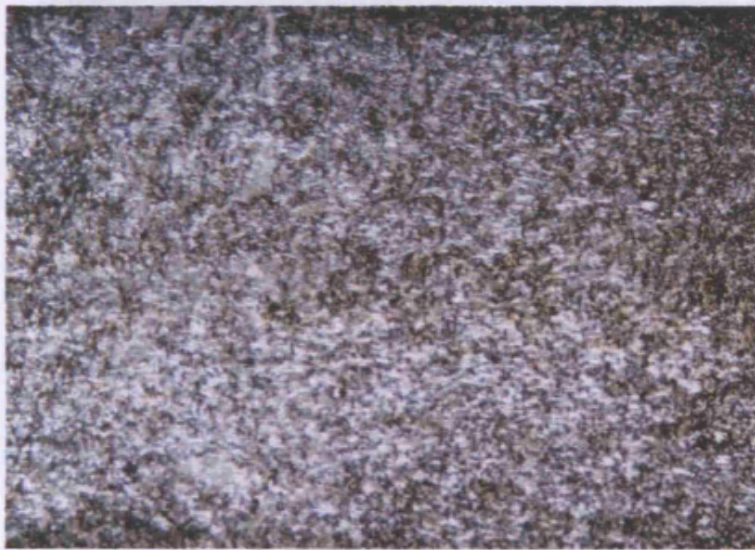
Sample 9: Microcrystalline gypsum with fibrous texture, well oriented. Pseudomorphs after needles also exist. Iron oxides and clays are responsible for the pinkish color of the vein.

Phaistos, Room 7, loose fragment of orange - purple gypsum typical of the colored variety of Messara

SC9: crossed polars 2,5x.

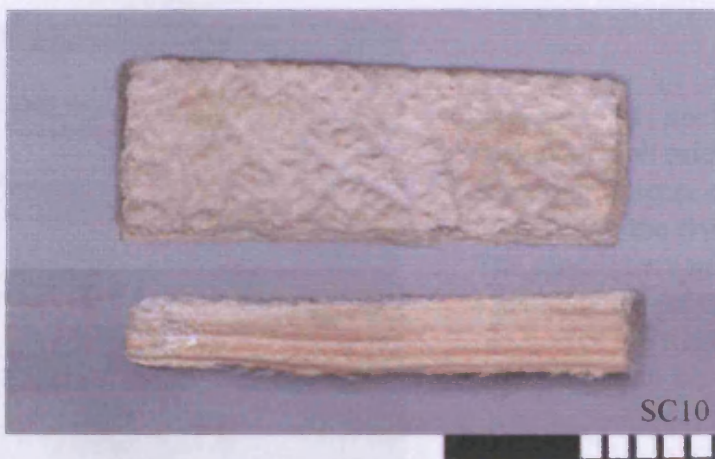
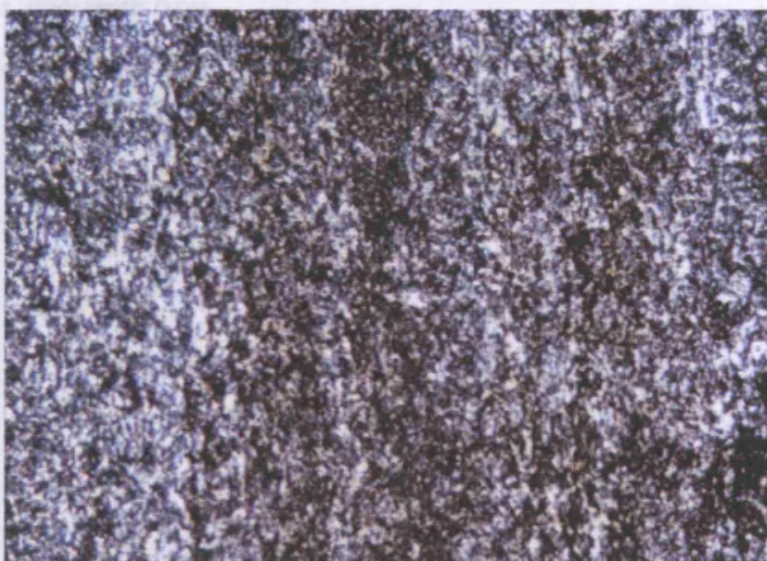
Agia Triada, loose fragment of pinkish gypsum

SC10: Microcrystalline granular gypsum with former needles and clay laminae.

SC10: crossed polars, 2,5.

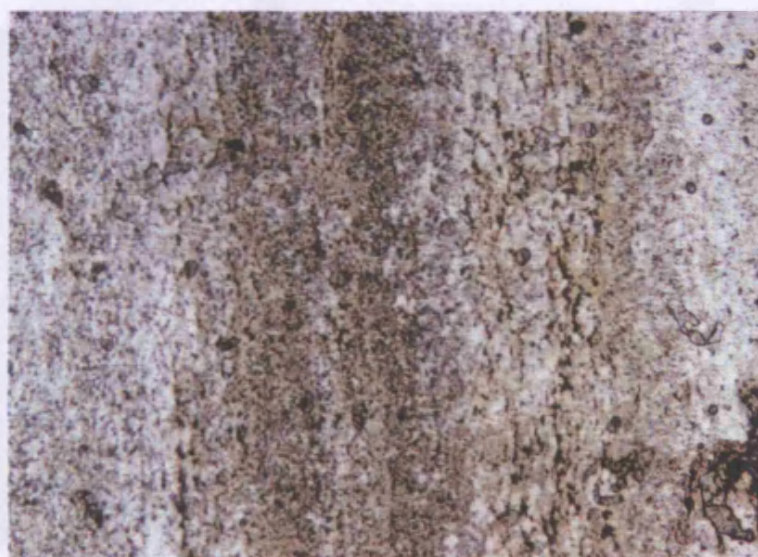
SC10: natural light, 2,5.

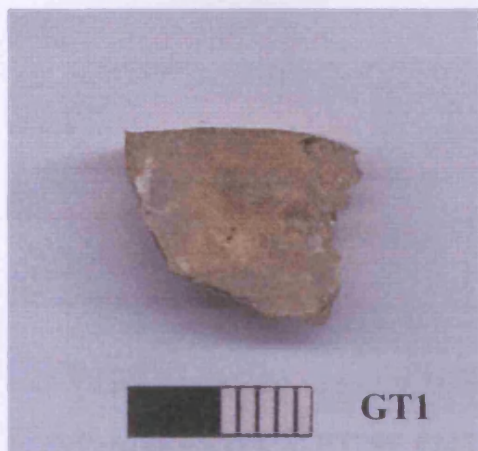
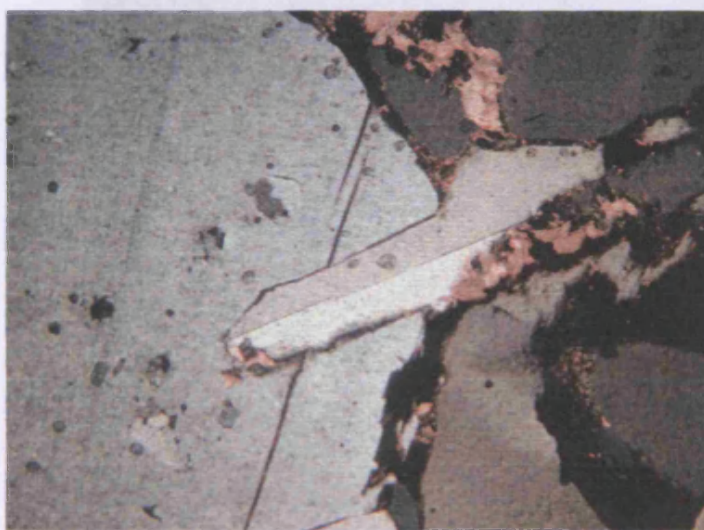
Sample GA1: unaffected selenite rock with well oriented crystals up to 3cm long. Intense dissolution observed in the crystal boundaries. The samples are very similar to the selenite boulders that can be seen on the side of the road on the way to Myrtia about 5 km before the village

Galatas, doorjamb base

GA1: crossed polars, 2.5x

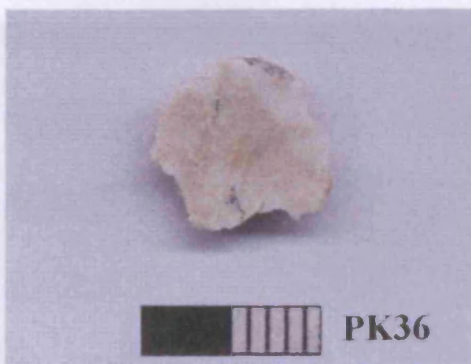
Palaikastro (PK90 ET88E #3473)

Sample PK36: Alabastrine rock derived from dehydration of selenite or the selenite nodules or lenses in a nodular and lenticular selenite. Pseudomorphs are outlined by microcrystalline carbonate seams and parallel elongated cloudy ameboid crystals which mimic selenite cleavage planes. In some parts granular xenotopic gypsum crystals apparently grow at the expenses of cloudy ameboid gypsum.

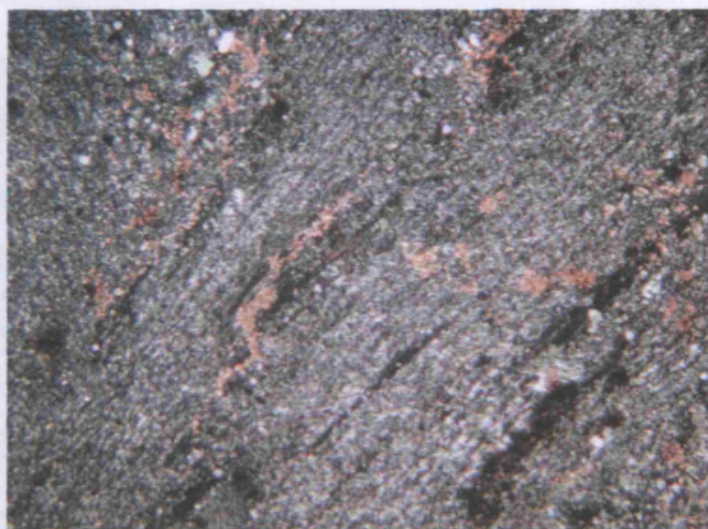
PK36: crossed polars, 2.5x.

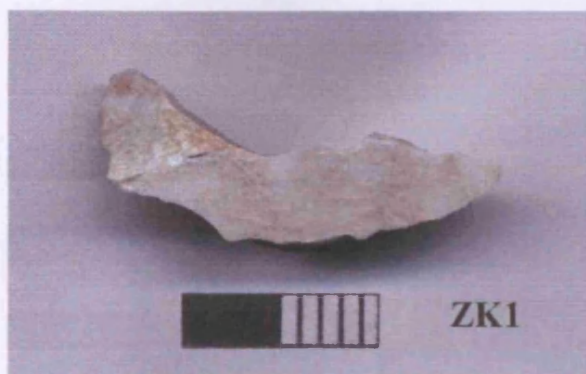
Zakros, doorjamb base, Room F

Sample ZK1: Alabastrine rock derived from dehydration of selenite or the selenite nodules or lenses in a nodular and lenticular selenite. Pseudomorphs are outlined by microcrystalline carbonate seams and parallel elongated cloudy ameboid crystals which mimic selenite cleavage planes. Granular xenotopic gypsum crystals, probably grown at the expenses of cloudy ameboid gypsum, are present as a rare feature.

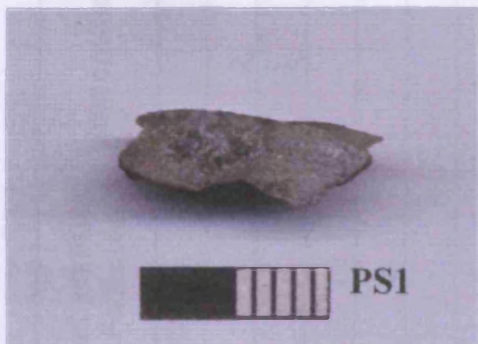
Pseira doorjamb, building AQ

Sample PS1: small selenite crystals in the nodules or lenses of nodular and lenticular selenite rock that is weathered due to dissolution along the crystal boundaries

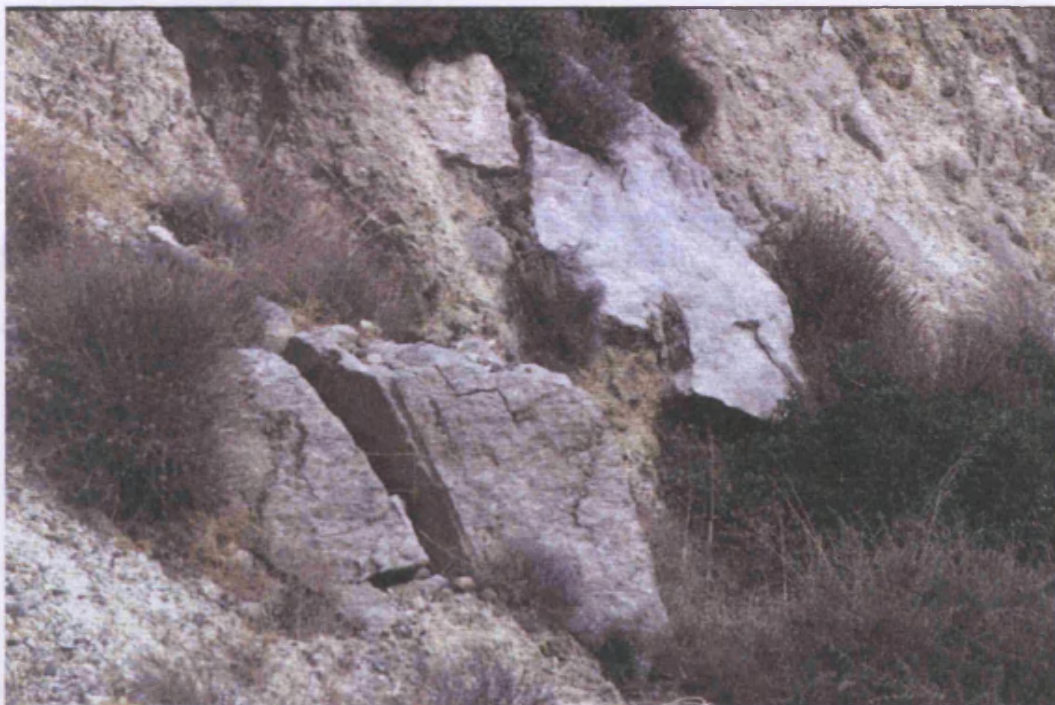
Fig.4.4: naturally split blocks of selenite at the outcrop of Myrtos along the modern road

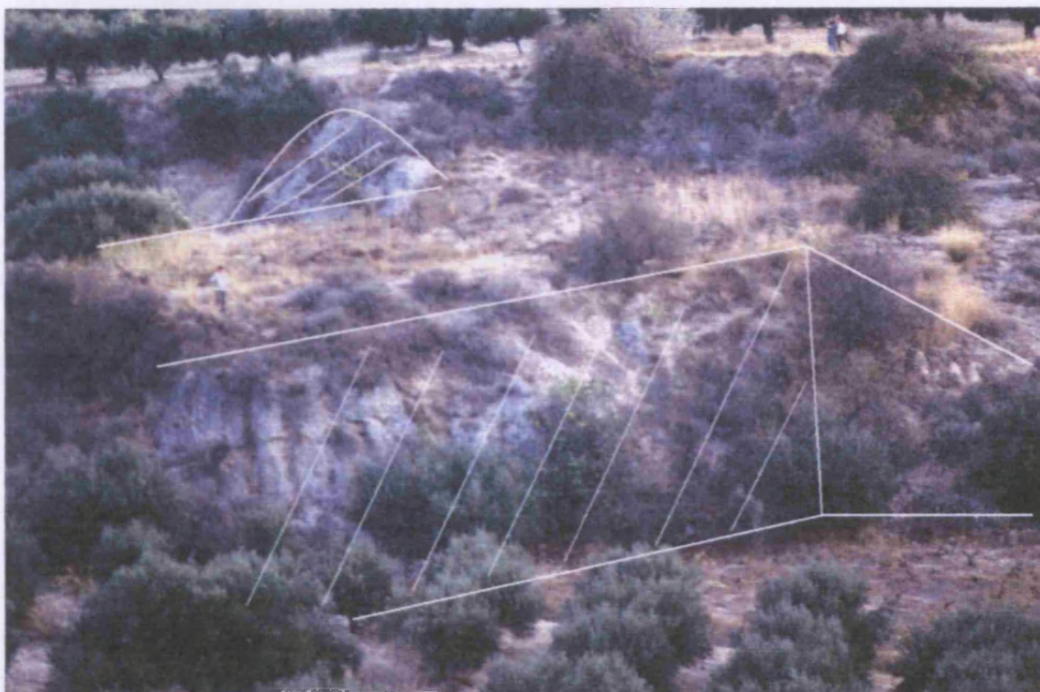
Fig.4.5: two possibly quarried terraces at location LC2

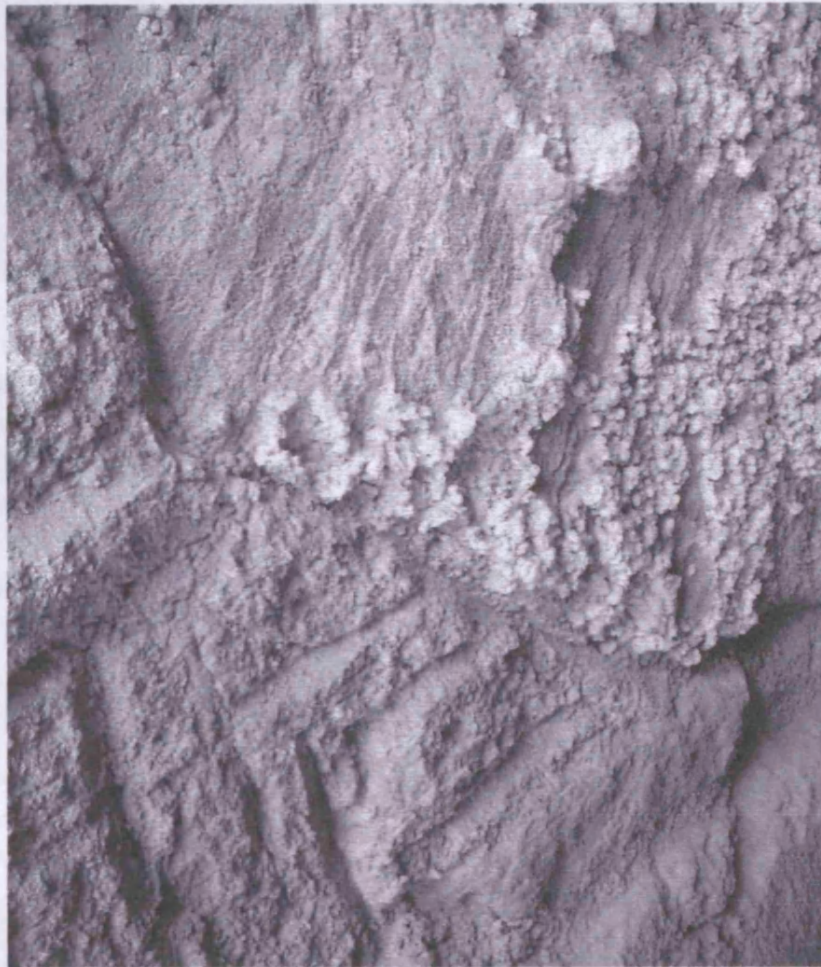
Fig.4.25:chisel marks on the upper block and characteristic pick marks with a V-shaped groove on the lower block, found in the second niche at the South Terrace Basements

Fig.4.25: chisel marks on the upper block and characteristic pick marks with a V-shaped groove on the lower block, found in the second niche at the South Terrace

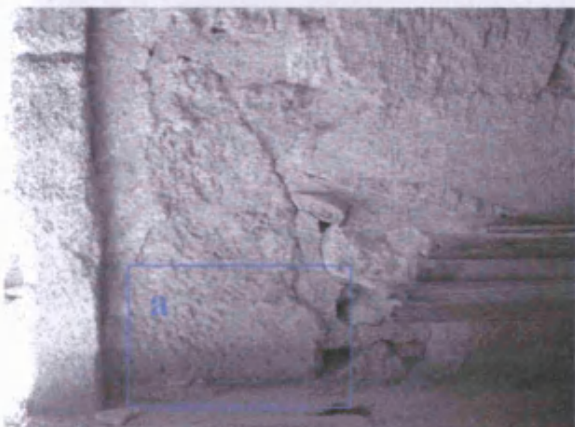
Fig. 4.30: tool marks, probably of axe/adze on the rear side of the south jamb of Magazine VIII

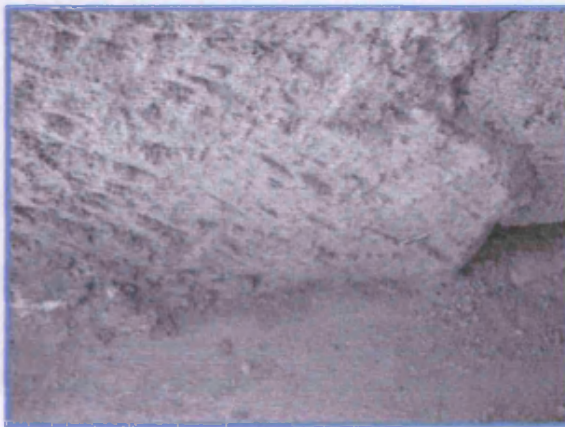
Fig. 4.31: detail (a) of previous photo

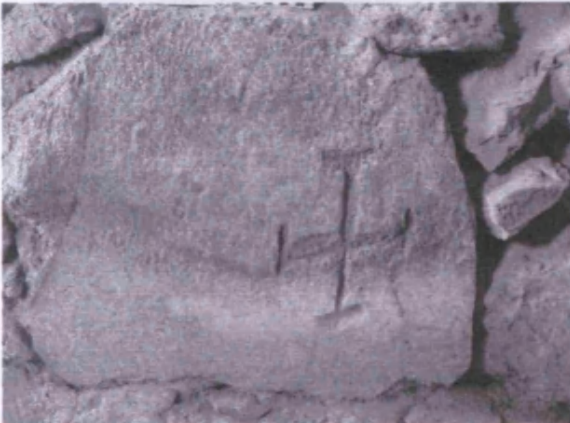
Fig.4.32: mason's mark incised with punch mark, (Early Passage Way with Protopalatial Magazines)

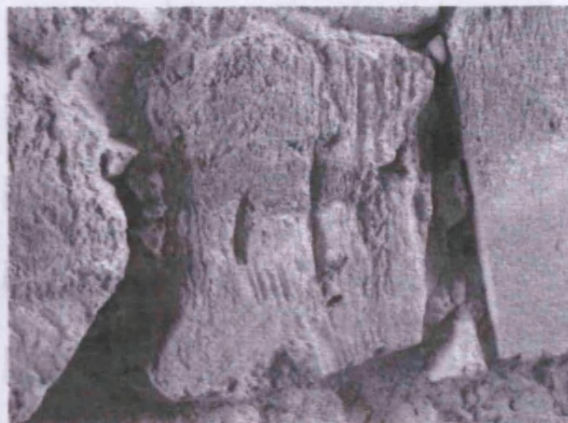
Fig.4.33: mason's mark incised with punch mark on surface worked with chisel (Early Passage Way with Protopalatial Magazines)

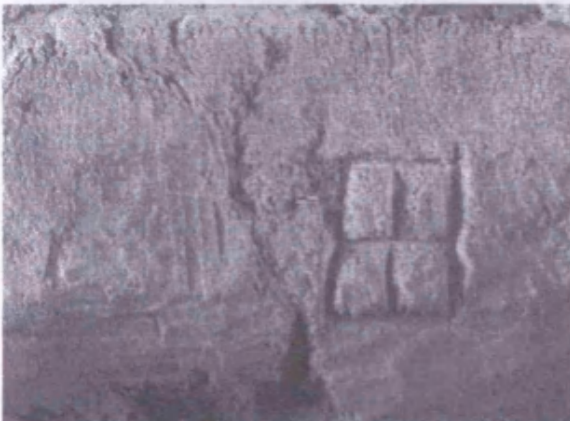
Fig.4.34: mason's mark incised with punch mark on surface worked with chisel (Long Gallery of the Magazines)

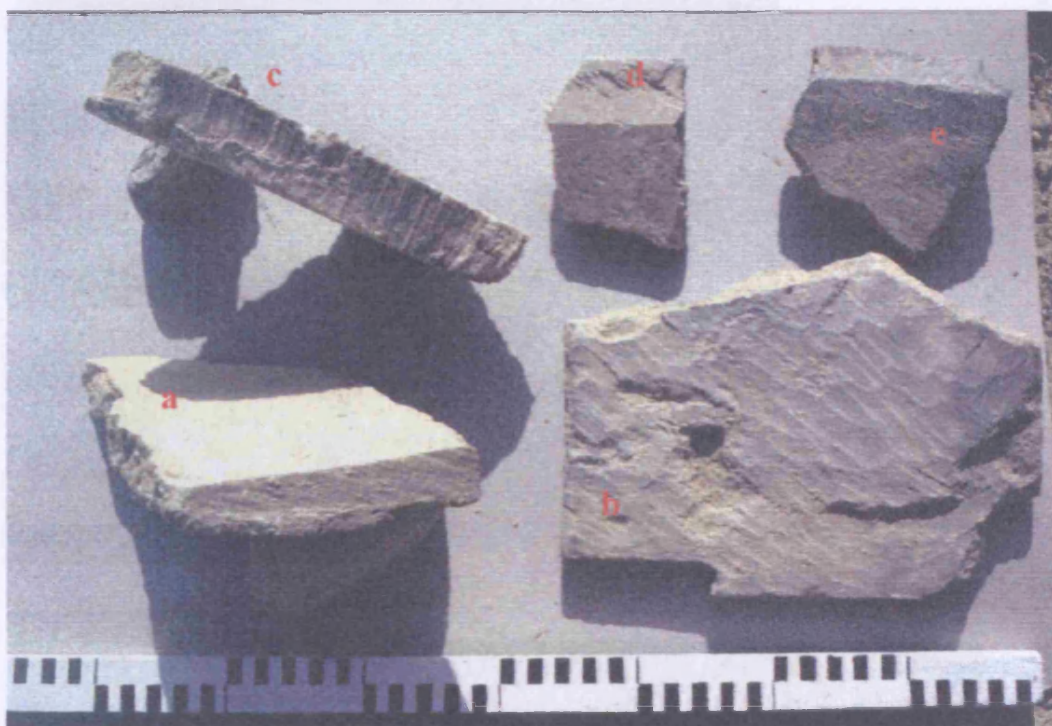
Fig.4.38: tool marks on loose slabs at the Pyrgos country house : a) hand saw, b) flat chisel 2cm wide, c, d, and e) flat chisel

Fig.4.38: tool marks on loose slabs at the Pyrgos country house : a) hand saw, b) flat

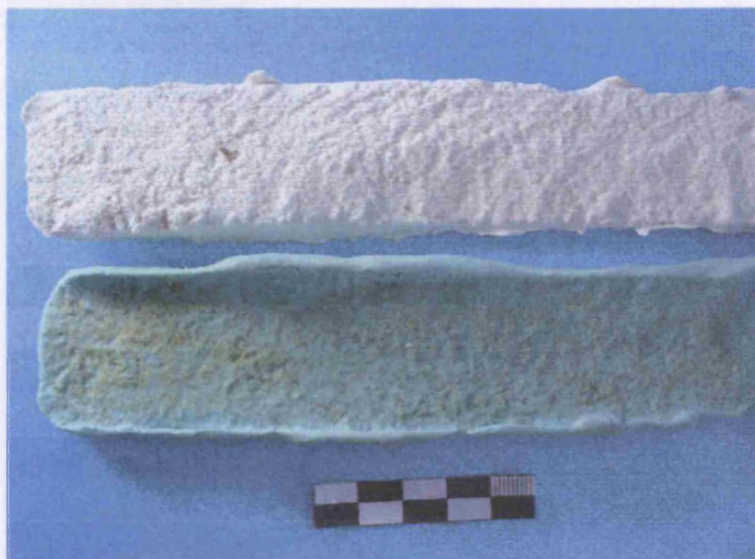
Fig.4.40: combined work of saw and chisel on the side of loose slab from Pyrgos

Fig.4.40: combined work of saw and chisel on the side of loose slab from Pyrgos

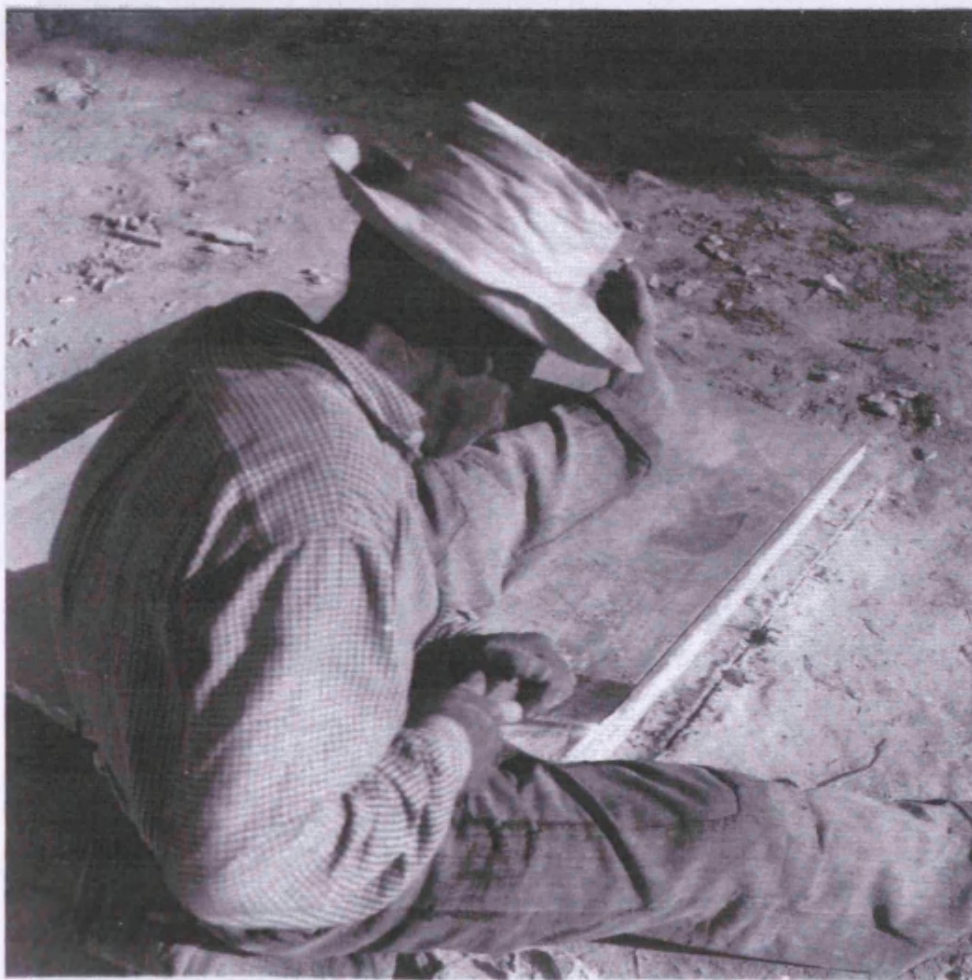
Fig.4.41: hand saw used by Levi's workman to trim the side of gypsum slab (photo courtesy of the Italian School of Archaeology, also published by Shaw (1973:68, Fig.60b))

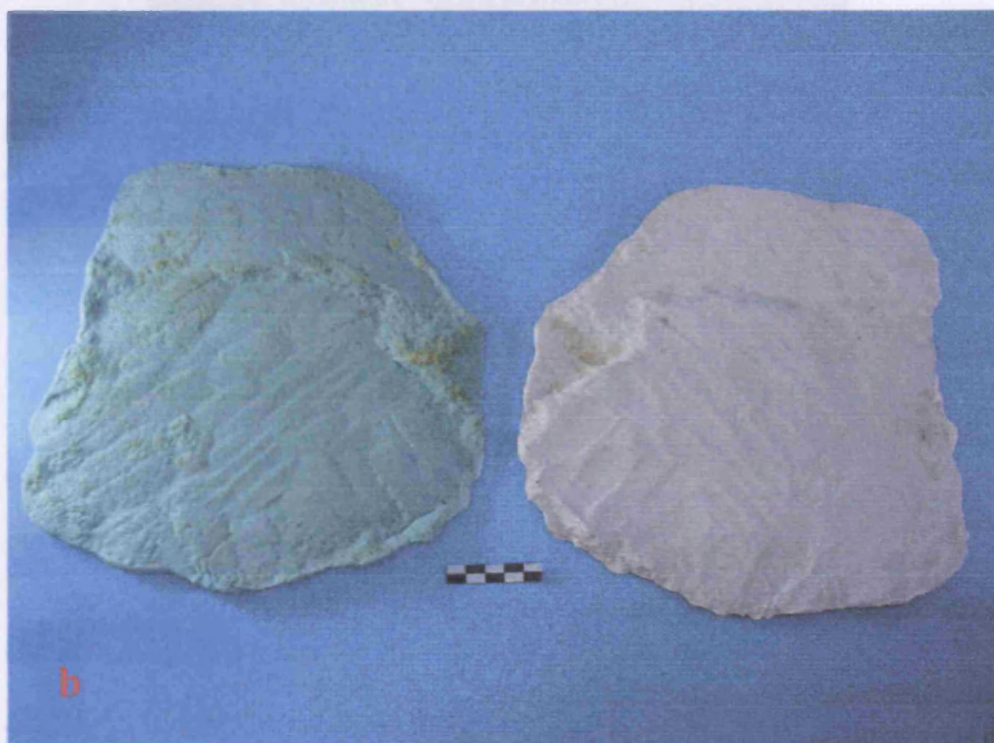
Fig.4.42: flat chisel marks 2cm wide on back surface of loose slab from Pyrgos

Fig.4.42: flat chisel marks 2cm wide on back surface of loose slab from Pyrgos

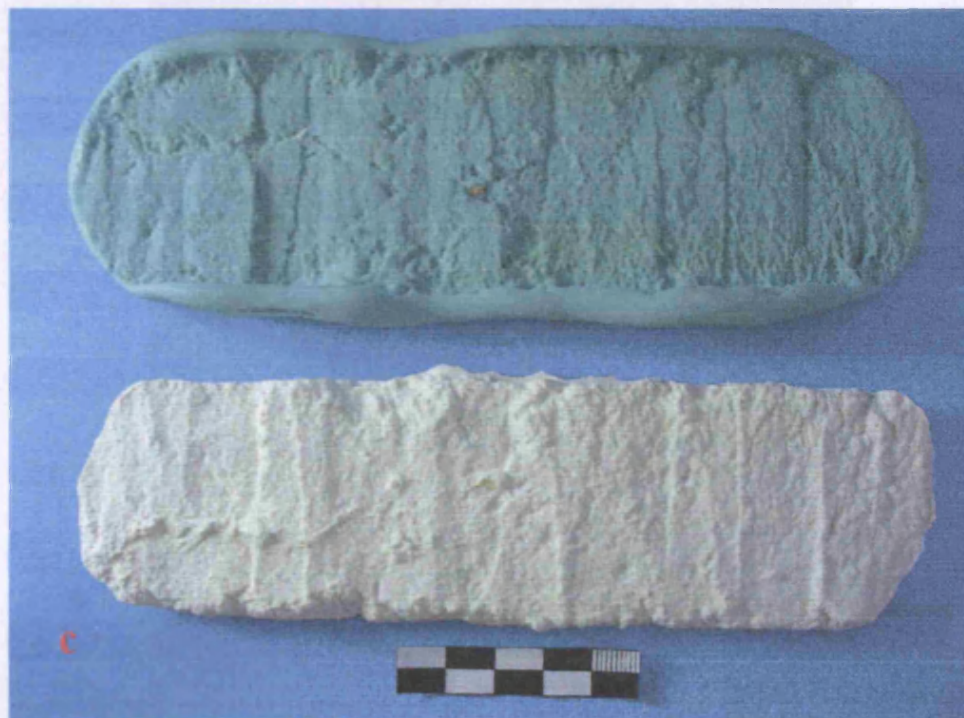
Fig.4.43: flat chisel marks on the side of loose slab from Pyrgos

Fig.4.43: flat chisel marks on the side of loose slab from Pyrgos

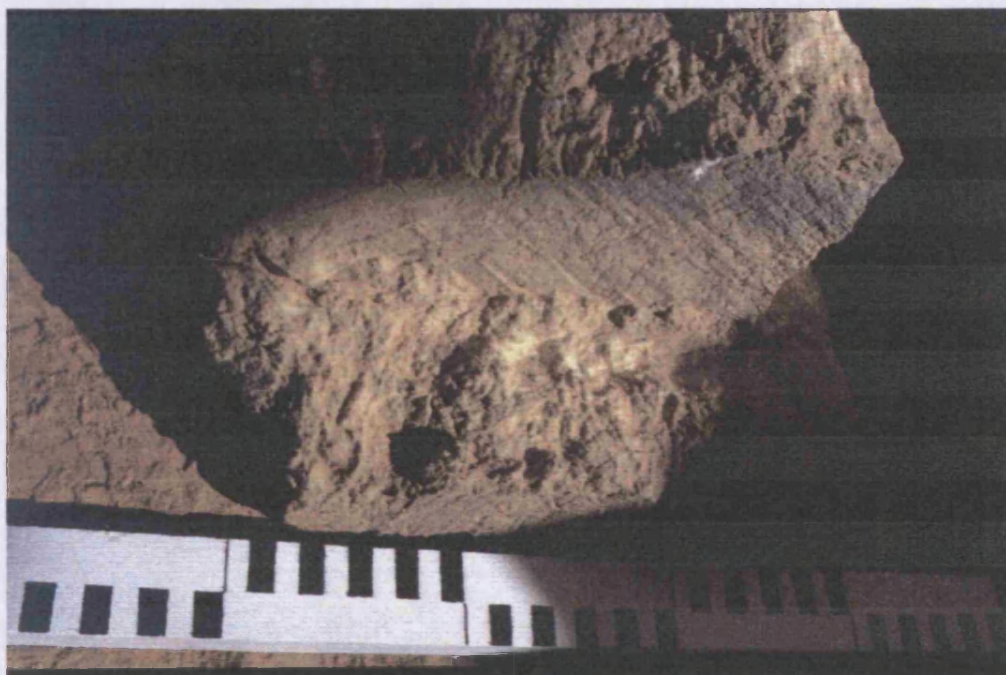
Fig.4.45: flat chisel marks on the rear sides of the a gypsum doorjamb base at Magaron Nirou

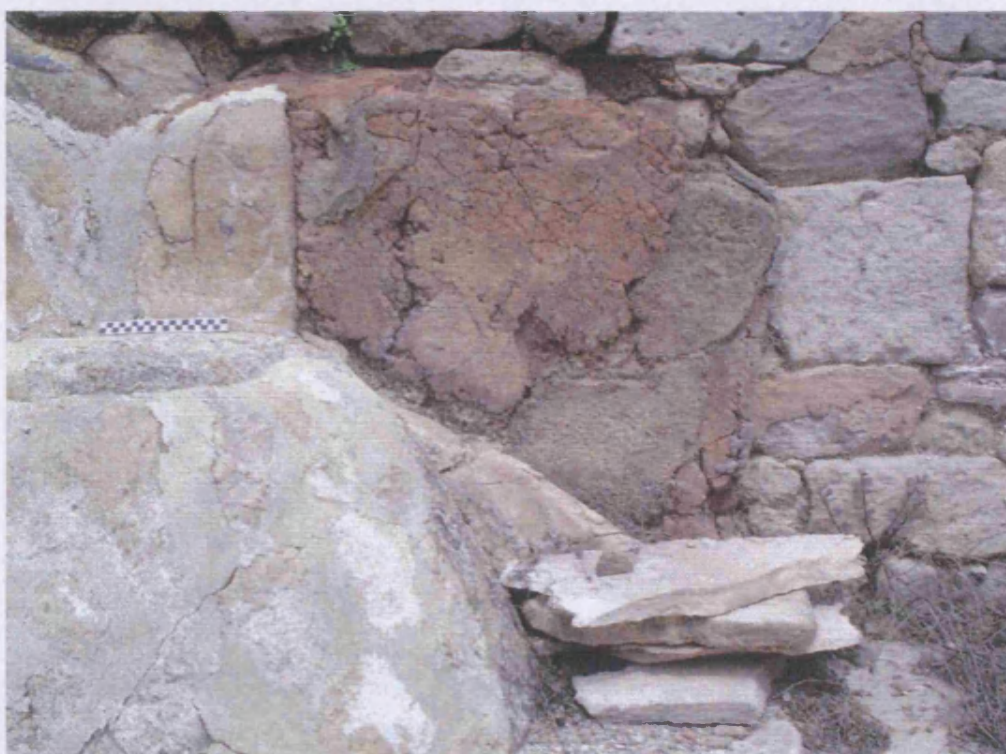
Fig 4.46: clayey mortar used for the attachment of the slab on to the walls, west wall of Room 45 in Agiia Triada

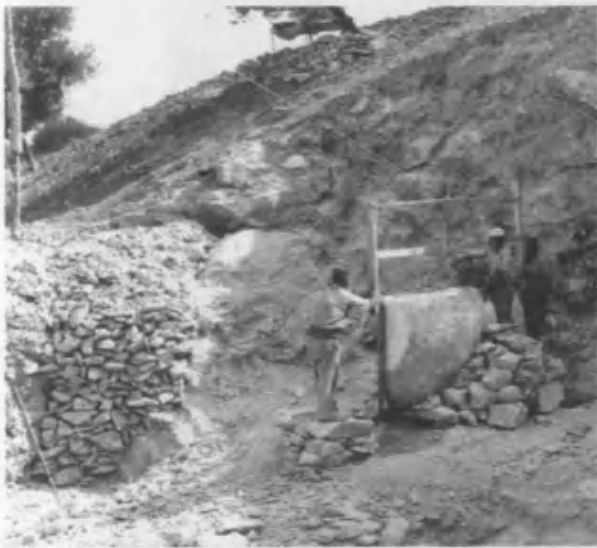
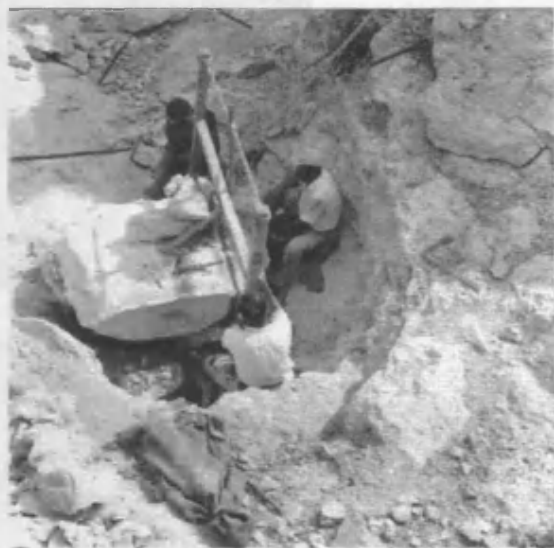
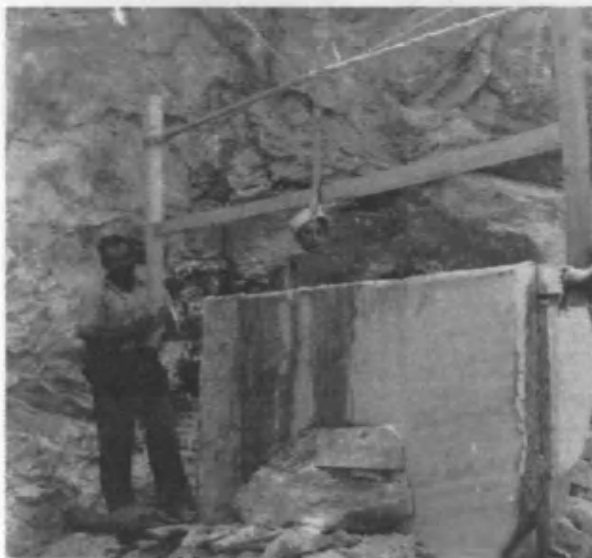
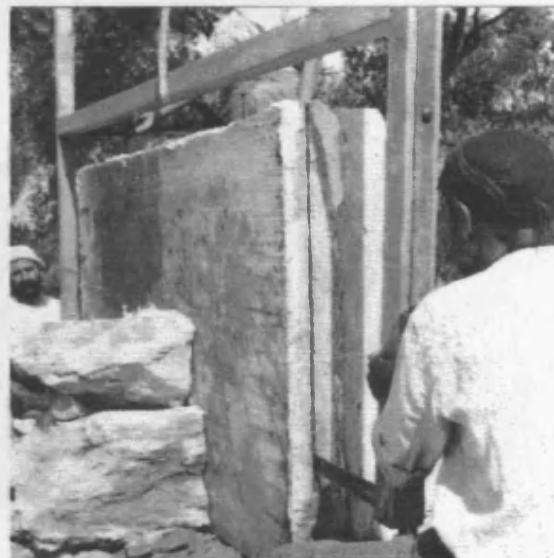
Fig 4.47a-d: use of steel toothless mason's saw in the Phaistos restoration campaign of Levi in the 1950's

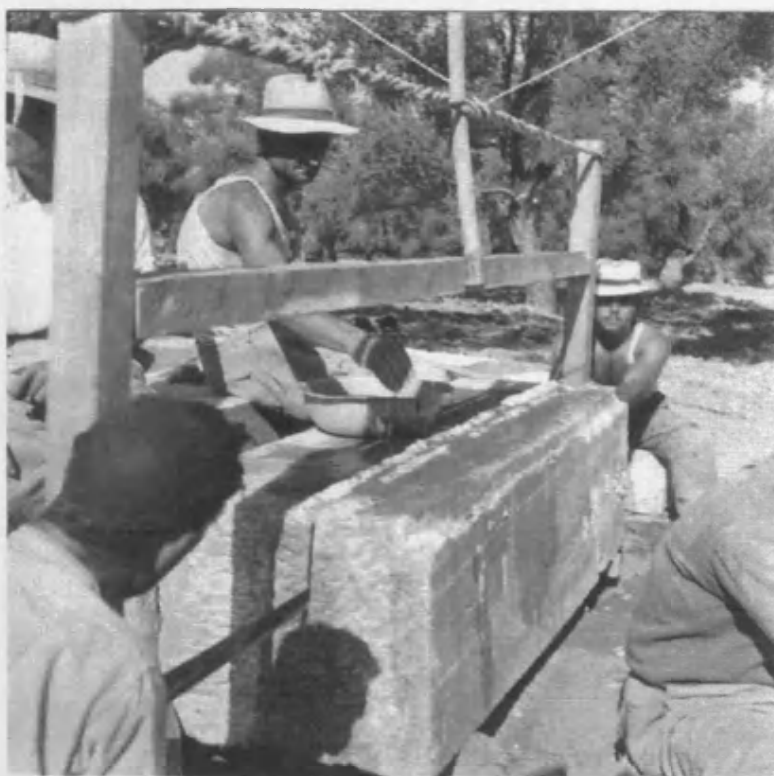
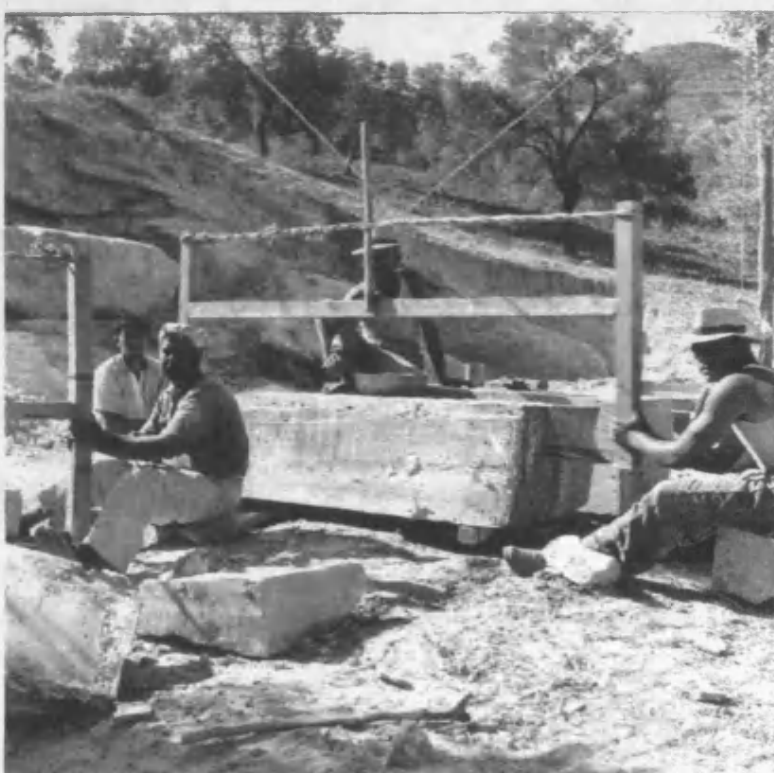
Fig.4.48a,b: sawing stone with the help of water as a cooling agent and abrasive powder

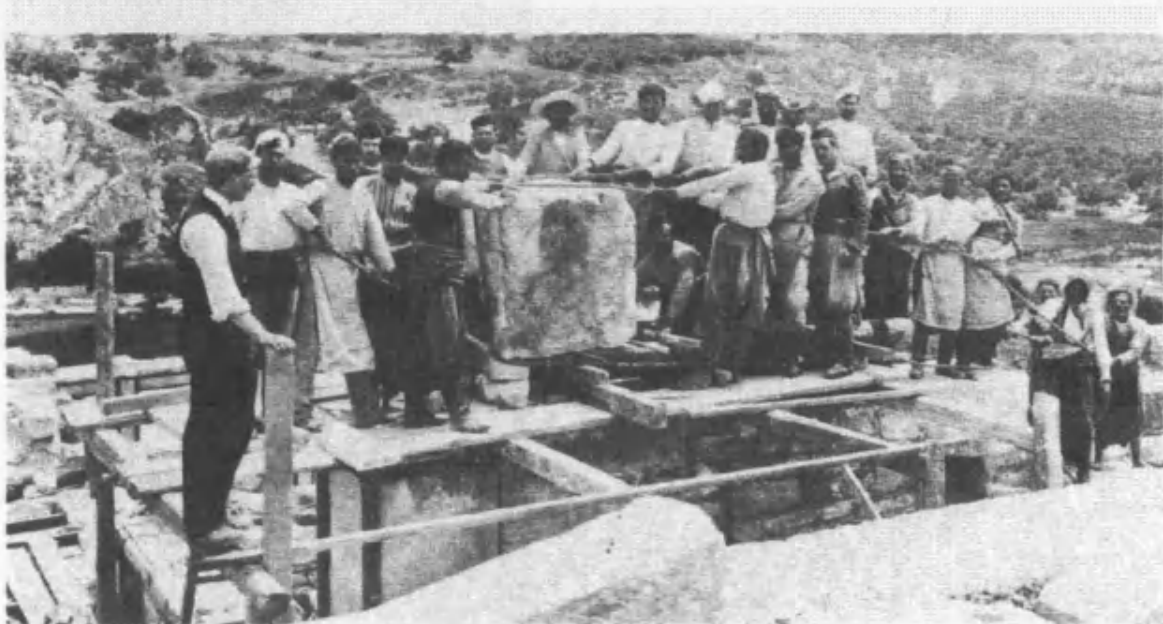
Approximate weight of the block: 2Kg or two tons

Fig.4.49: C. Doll supervising the re-positioning of the landing block of the fourth flight of the Grand staircase at Knossos (photo published by A.Brown 1994:98, fig.52a and 52b)
